DEEP SEA MOORINGS FISHBITE HANDBOOK

March 1987

TECHNICAL REPORT

Reproduction in whole or in part is permitted for any purpose of the United States Government. This report should be cited as:
Woods Hole Oceanogr. Inst. Tech. Rept. WHOI-87-8.

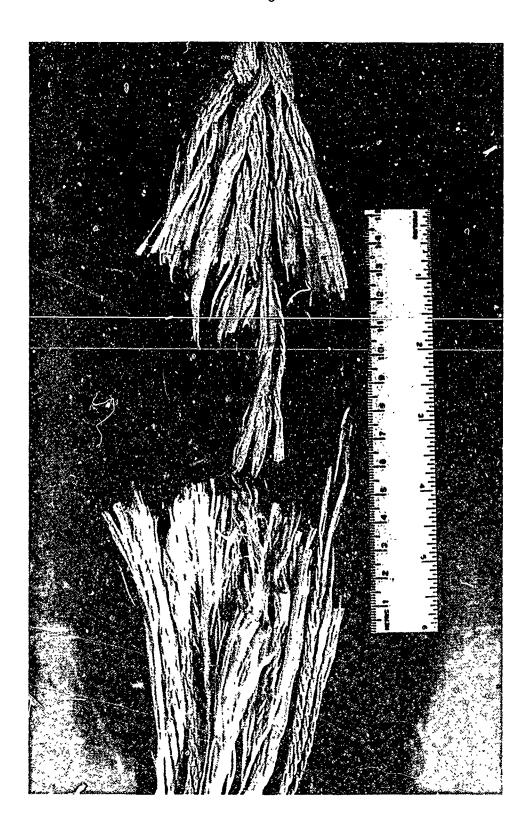
Figure 1.2 1/2" Nylon rope damaged by fishbite (Prindle and Walden, 1975).
